ZARGA MOORING DECK ACCIDENT LESSONS LEARNED

Oil Companies International Marine Forum (OCIMF) North America
15 March 2018

ZARGA MOORING DECK ACCIDENT

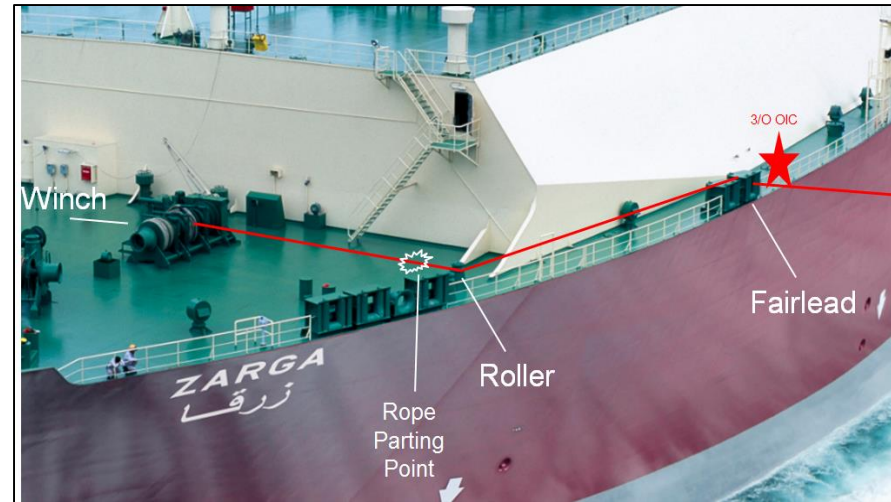
- Occurred on 2 March 2015 at Milford Haven
- An ultra-high modulus polyethylene (UHMPE) fiber line fitted to a 22 meter (m) polyethylene tail failed while being tensioned to warp the vessel along the berth
- The Third Officer was seriously injured when struck by the failed line
- Joint investigation by the United Kingdom (UK) and the Republic of the Marshall Islands (RMI)
- Report available on the Marine Accident Investigation Branch (MAIB) website

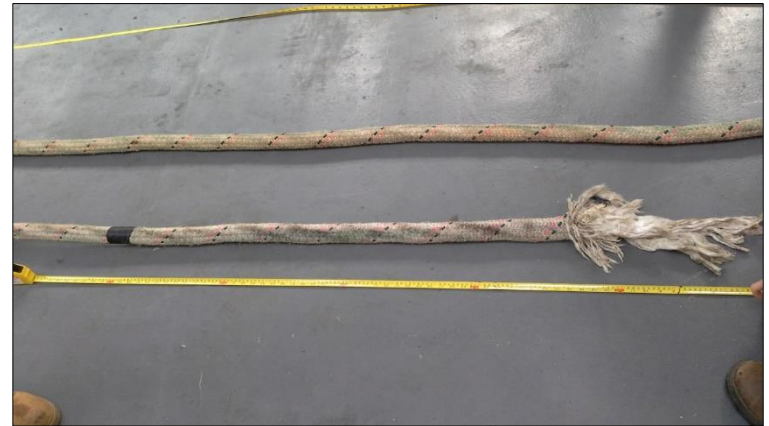
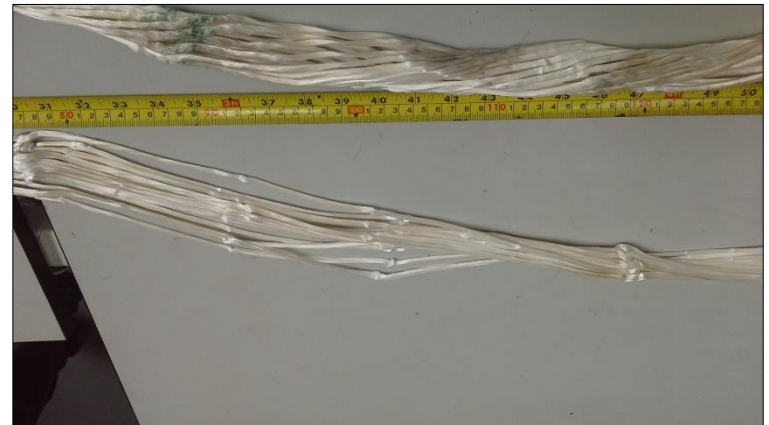
FAILURE OF UHMPE FIBER MOORING LINE

- Loss of strength over time due to kink bands created by axial compression
 - Minimum breaking load of the line was 137 tons, failed at 24 tons
- Service related causes of axial compression include: twisting of the line, bending around improperly sized deck fittings, and cyclic loading
- Jacketed core prevented detection of damaged fibers
- Snap back underestimated

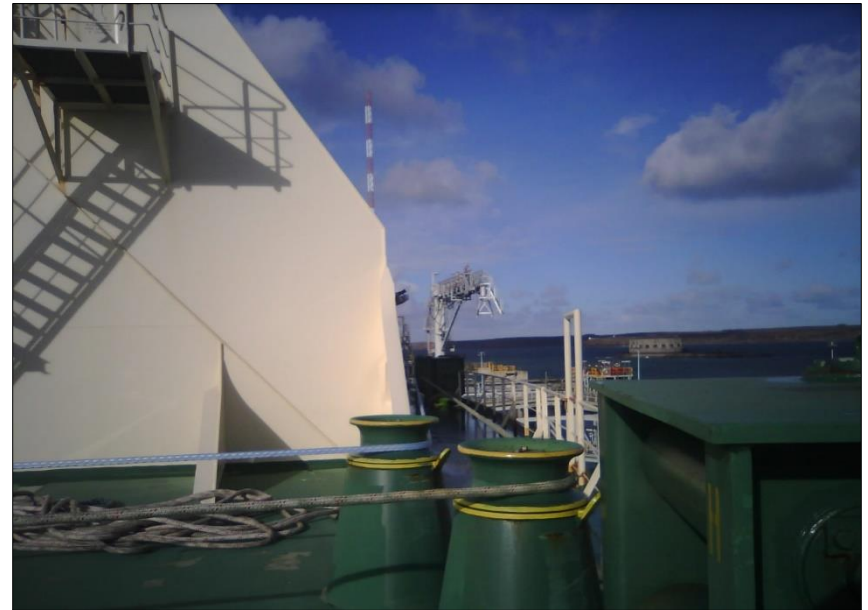
IMPROPERLY SIZED DECK FITTINGS

- Manufacturer's guidance stated the ratio of the diameter of the deck fittings to the diameter of the mooring line (D/d) was critical
- Minimum recommended D/d of 12:1 for lines on board ZARGA
 - Pedestal roller $D/d = 10.22$
 - Roller fairlead $D/d = 9.1$
- Factors related to mooring lines not taken into account when fittings were selected by the builder

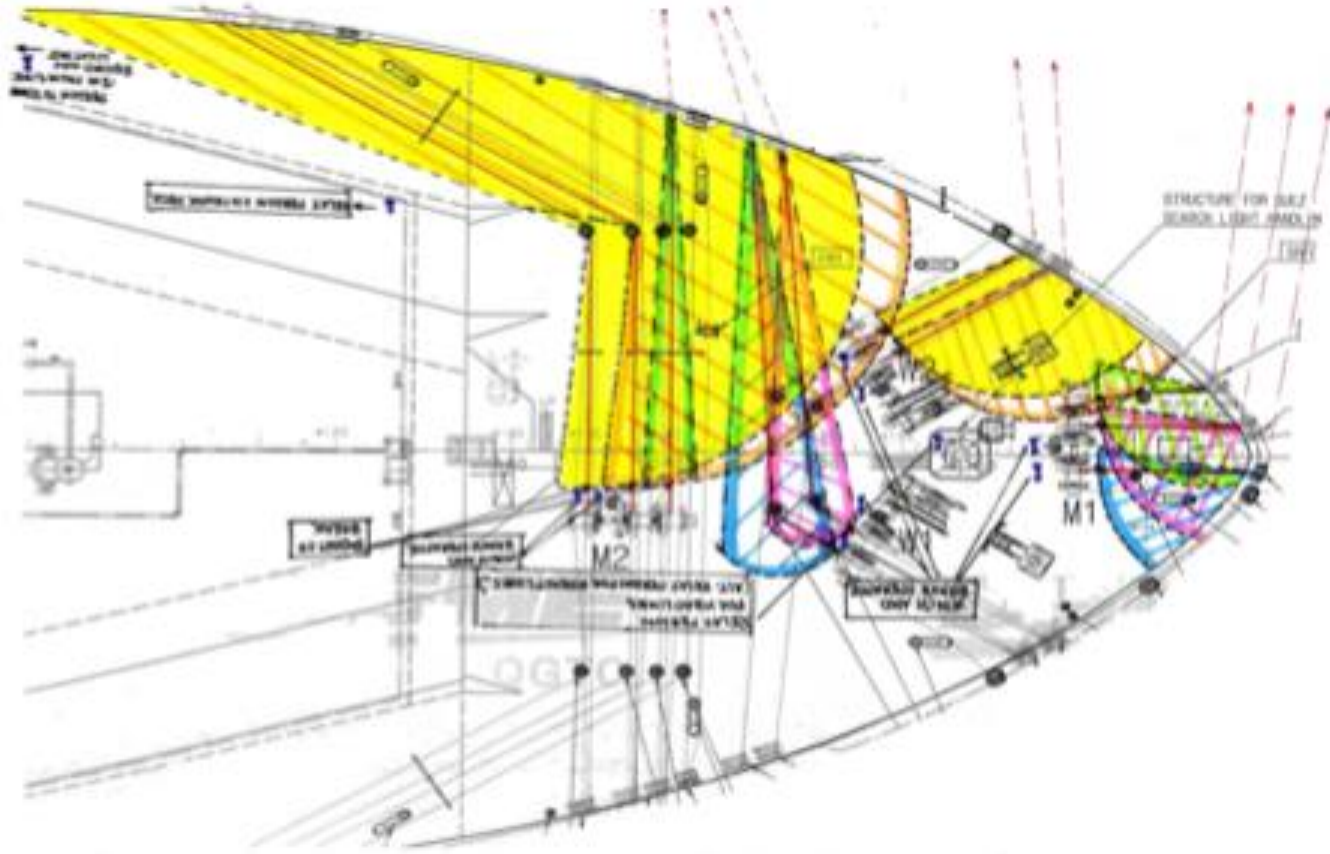
SNAP BACK ZONES - REVISED

- The potential for snap back due to the use of polyethylene tails was underestimated
- The arrangement of the mooring deck meant that the entire foredeck area and portions of the main deck adjacent to the cargo dome were a snap back zone
- The line manufacturer's guidance regarding minimum D/d ratio was not taken into account during the selection of deck fittings during new construction
- The potential for significant reductions in line strength due to axial compression was recognized by the line manufacturer
- The jacketed core construction rendered ship management's line inspection procedures ineffective
