**OCIMF
Europe & Africa
Regional Marine
Forum
19 June 2018**

**MAIB investigation:
Failure of an HMPE
mooring line on board
LNG carrier *Zarga***

Howard Flegg
Inspector of Marine Accidents

Failure of HMPE mooring line on board LNG carrier *Zarga* resulting in serious injury to one crewman

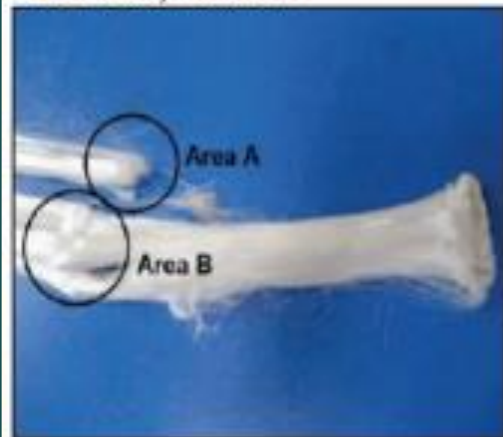
Area A - Kink band filament failure

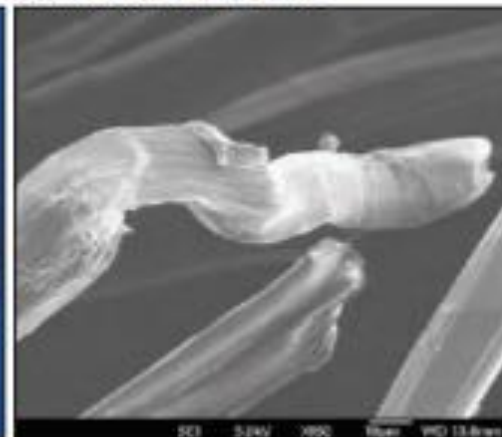
Area A - Kink band filament failure

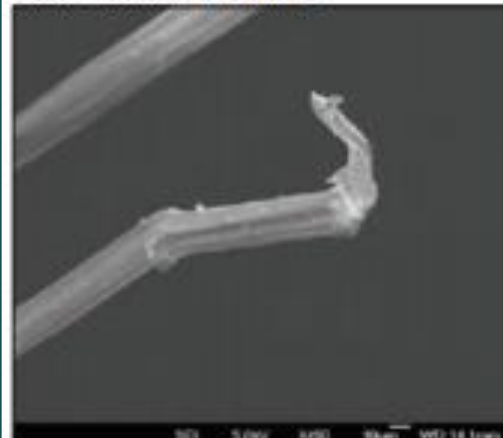
Area B - Kink band

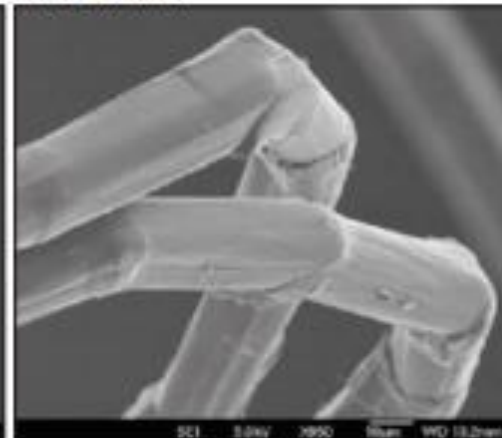
Bend and Z kinks in filaments

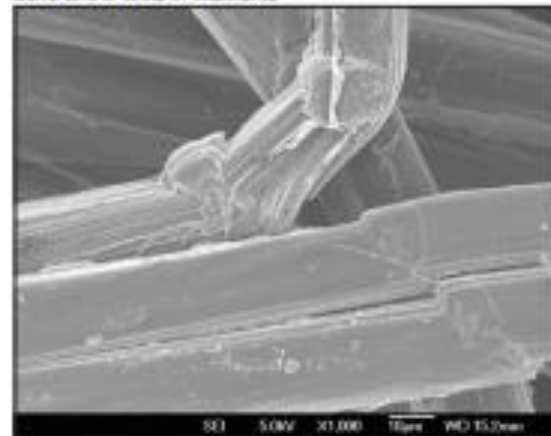
SEM Examination

- *Failure due to axial compression fatigue*
- *HMPE is widely accepted in the industry as not being sensitive to axial compression fatigue ... something has occurred either in the application, material, rope design or use of mooring tail ..*

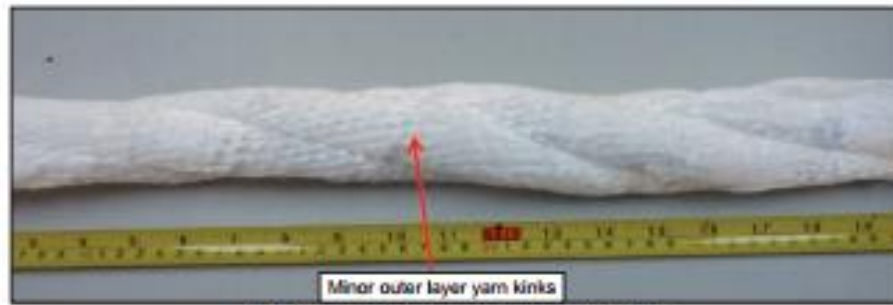
Figure 37: New rope minor kinks in outer yarns
