OIL COMPANIES INTERNATIONAL MARINE FORUM

RESULTS OF A SURVEY INTO LIFEBOAT SAFETY

July 1994

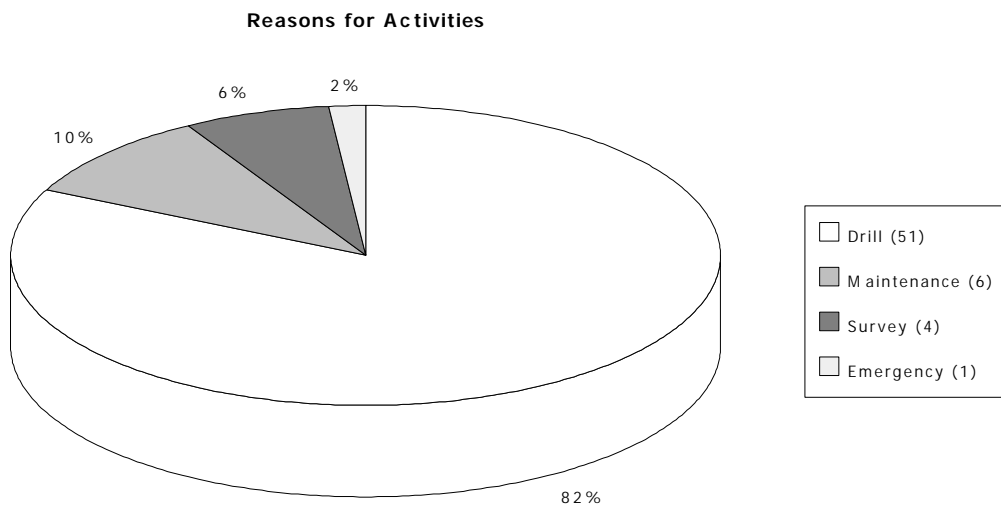
Fig 1.

As expected, a large proportion of the reported lifeboat incidents occurred during drills. Almost half of the reported incidents occurred during the recovery of boats after drills and, in particular, during the process of lifting the boat from the water to the vicinity of the upper deck.

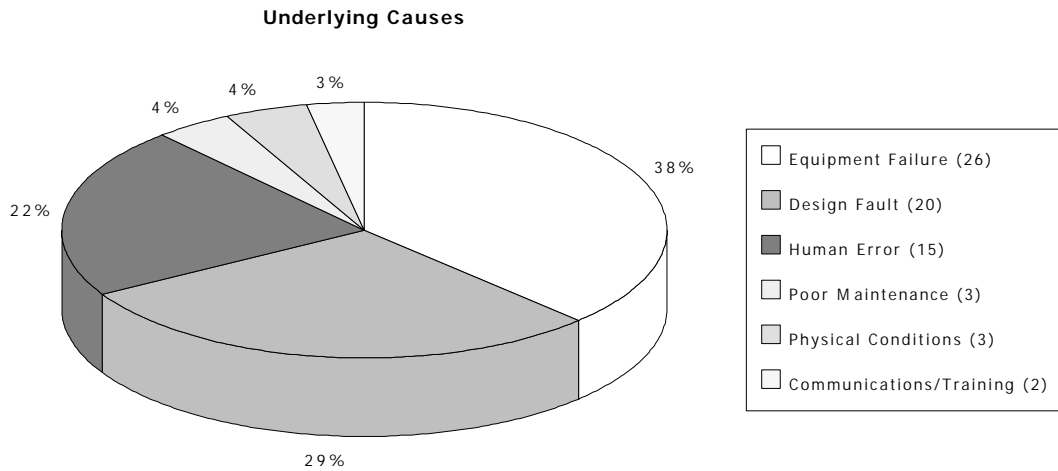
Fig 3.

Equipment failures and design shortcomings were responsible for approximately two thirds of all reported lifeboat incidents. Human error accounted for most of the rest. Of those reported incidents attributed to hardware component failure, brakes, lifting hooks and quick release mechanisms were implicated in almost two thirds of the incidents.

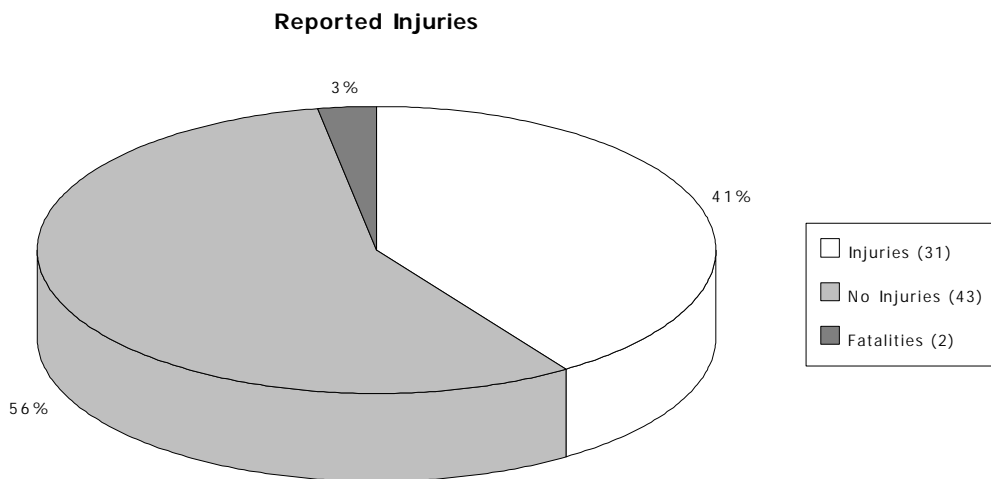
Fig 5

Almost half of the reported lifeboat incidents resulted in injury to personnel. Two such incidents, both of which related to the hook/release gear, resulted in four fatalities. OCIMF interviewed many mariners during the survey and discovered a surprising lack of confidence in modern lifeboats which is causing some reluctance on the part of ship crews to conduct the necessary lifeboat drills intended to help them protect their lives.

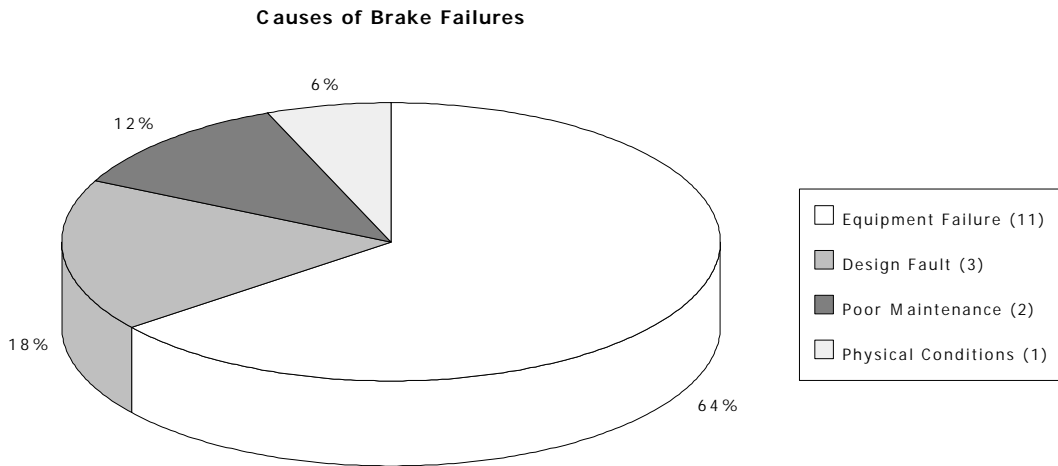
Fig 7.

About two thirds of reported brake and hook/release system failures were apparently due to a combination of design shortcomings and mechanical failure.
