# OCIMF Regional Marine Forum

Contractor Injured during Buoy Deployment

Date: March 15<sup>th</sup>, 2018

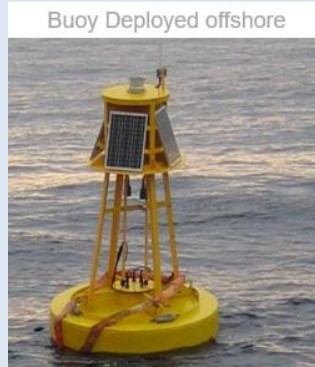
150m of amsteel blue rope past swivel then to hard ball float;

15m amsteel blue rope connected to 4m of 1/2" galvanized chain by swivel/shackle arrangement.

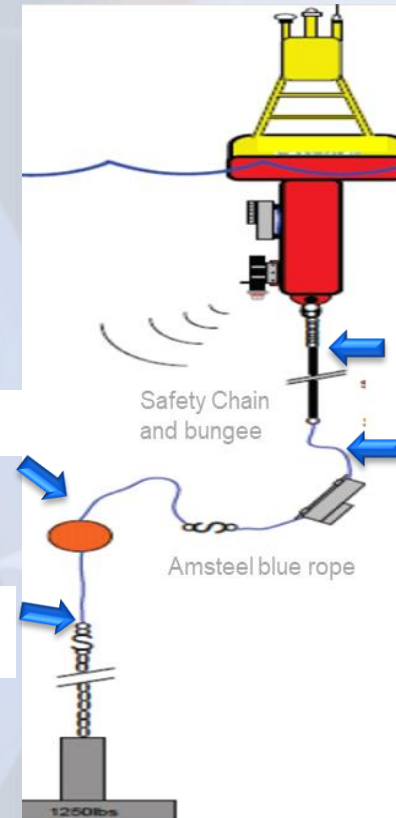
A safety chain and bungee (20m in length 5m SS chain/15m of rubber bungee);

50m of amsteel blue rope with sinker and swivel attached by 5/8" shackles;
