SIRE 2.0 Report

Report LXHQ-2893-4382-6569 (C)

Vessel Name	Crude/Products Tanker CHEVRON SHIPPING 194
IMO	3913234
Inspection Date	01-August-2022
Report Type	Contingency
Contingency Reason	Tablet damaged

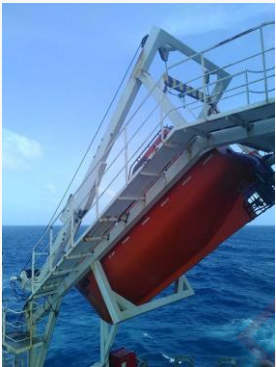
5.4.2. Were the Master and officers familiar with the operation of the free-fall lifeboat, its release systems and its launching appliance, and was the equipment in satisfactory condition with records available to demonstrate that it had been inspected and tested in accordance with company procedures?

Hardware Free from obvious deterioration or deficiency.

This information should not be used to form a commercial opinion of the subject vessel - Engine and rudder movement satisfactorily tested.

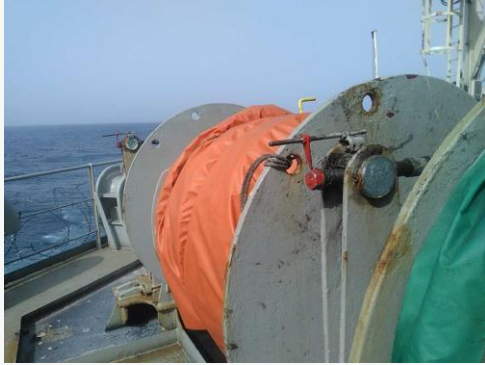
- 9.1.1. Were the Master and deck officers familiar with the company procedures for the testing and correct operation of the mooring winch brakes, and were records available to demonstrate that brakes had been tested periodically, after maintenance or when there was evidence of premature brake slippage?

Hardware Free from obvious deterioration or deficiency.

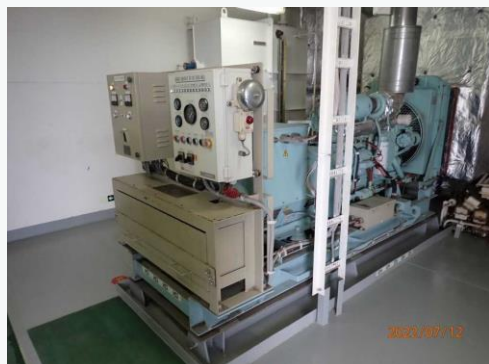
10.2.1. Were the officers familiar with the starting procedure for the emergency generator and were records available to demonstrate that the emergency generator had been tested according to company procedures?

Hardware	Free from obvious deterioration or deficiency. This information should not be used to form a commercial opinion of the subject vessel - Satisfactorily tested using both primary and secondary means.
Process	As expected – procedure and/or document present.
Human	Senior Engineer Officer: As expected.

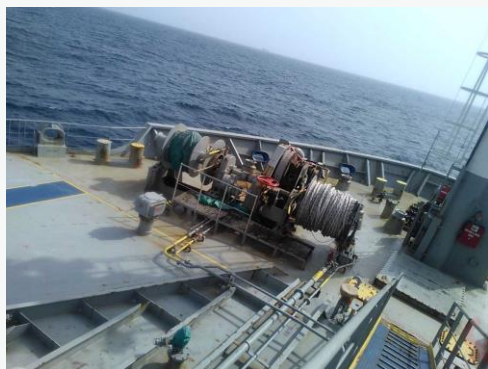
11.1.7. Was photograph no.7, forecastle port side looking towards fairleads, representative of the condition as seen onboard at the time of the inspection and, if so, was it free of any areas for concern?

Photograph Photo provided representative.

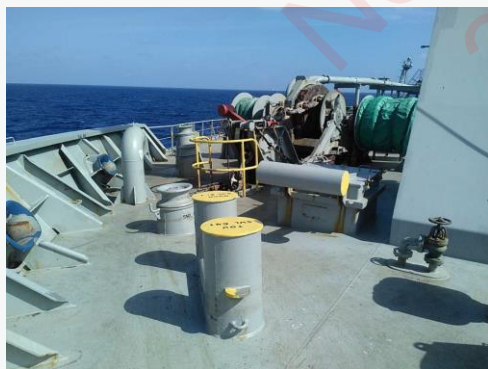
11.1.8. Was photograph no.8, forecastle starboard side looking towards fairleads, representative of the condition as seen onboard at the time of the inspection and, if so, was it free of any areas for concern?

Photograph Photo provided representative.

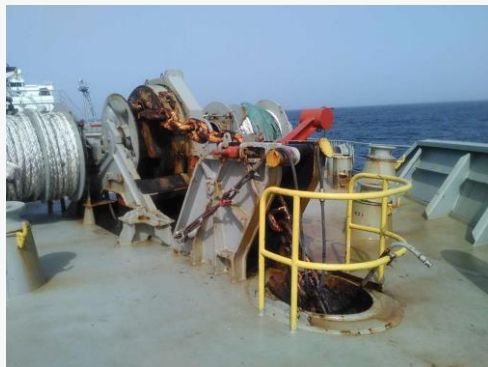
11.1.9. Was photograph no.9, port or starboard windlass, representative of the condition as seen onboard at the time of the inspection and, if so, was it free of any areas for concern?

Photograph Photo provided representative.

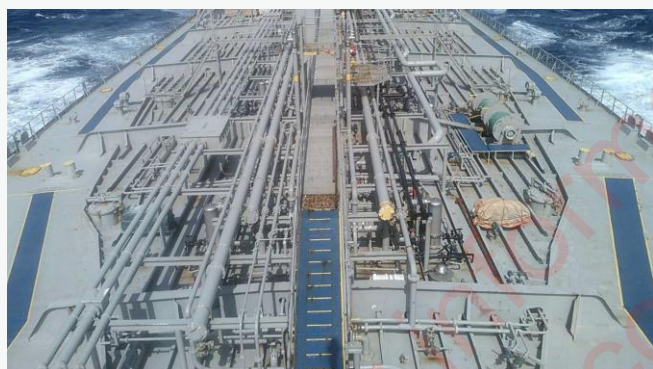
11.1.10. Was photograph no.10, forward main deck showing condition of deck (and external framing), representative of the condition as seen onboard at the time of the inspection and, if so, was it free of any areas for concern?

Photograph Photo provided representative.

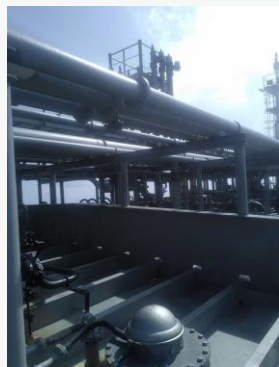
11.1.11. Was photograph no.11, Forward main deck showing condition of pipe rack, representative of the condition as seen onboard at the time of the inspection and, if so, was it free of any areas for concern?

Photograph Photo provided representative.

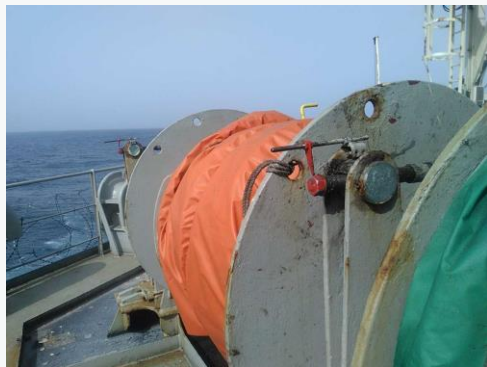
11.1.12. Was photograph no.12, one mooring winch including the brake setting arrangement, representative of the condition as seen onboard at the time of the inspection and, if so, was it free of any areas for concern?

Photograph Photo provided representative.

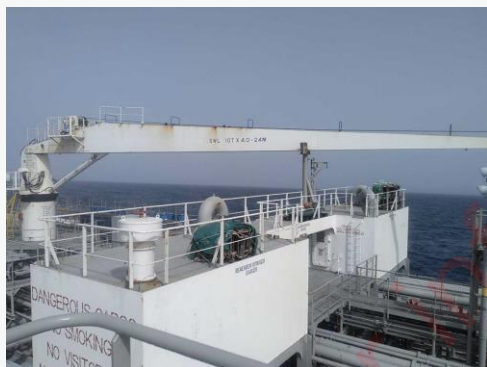
11.1.13. Was photograph no.13, one hose crane with an overall view, representative of the condition as seen onboard at the time of the inspection and, if so, was it free of any areas for concern?

Photograph Photo provided representative.

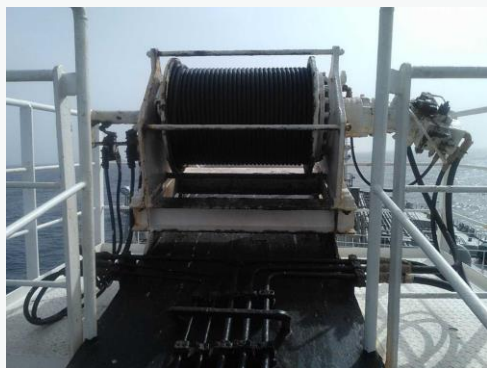
11.1.14. Was photograph no.14, one hose crane hoisting winch, stowed wire and limit switches, representative of the condition as seen onboard at the time of the inspection and, if so, was it free of any areas for concern?

Photograph Photo provided representative.

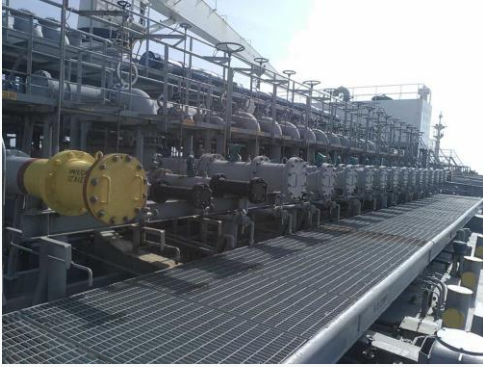
11.1.15. Was photograph no.15, starboard manifold looking from aft to forward, representative of the condition as seen onboard at the time of the inspection and, if so, was it free of any areas for concern?

Photograph Photo provided representative.

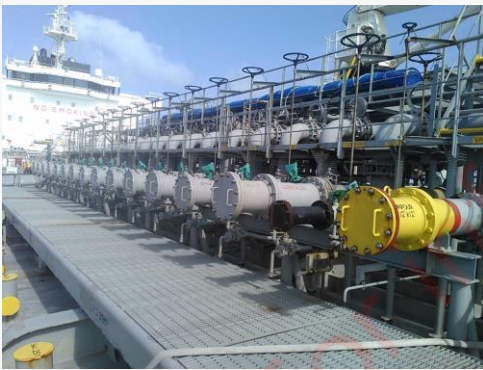
11.1.16. Was photograph no.16, starboard manifold looking forward to aft representative of the condition as seen onboard at the time of the inspection and, if so, was it free of any areas for concern?

Photograph Photo provided representative.

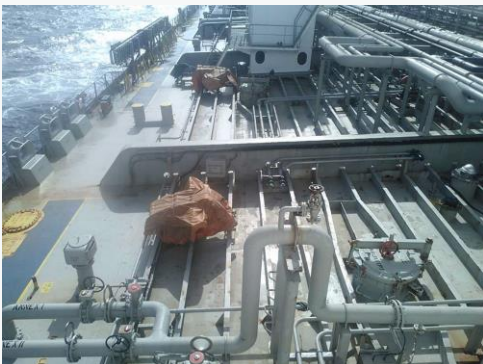
11.1.17. Was photograph no.17, aft main deck showing condition of deck (and external framing), representative of the condition as seen onboard at the time of the inspection and, if so, was it free of any areas for concern?

Photograph Photo provided representative.

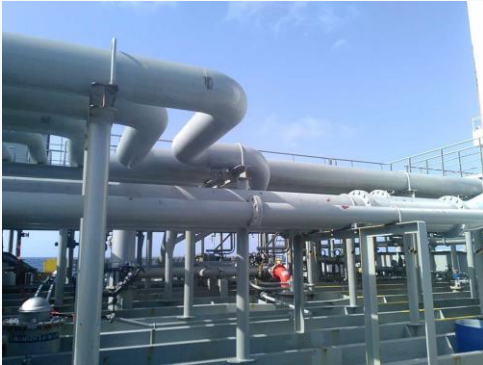
11.1.18. Was photograph no.18, aft main deck showing condition of Piperack, representative of the condition as seen onboard at the time of the inspection and, if so, was it free of any areas for concern?

Photograph Photo provided representative.

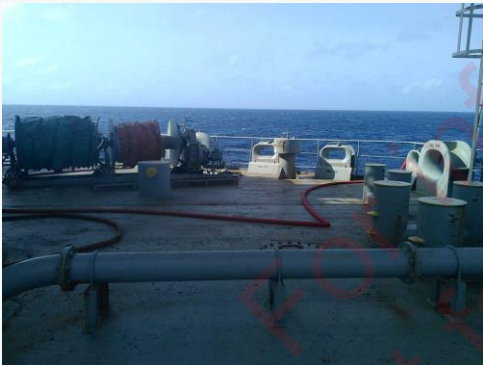
11.1.19. Was photograph no.19, poop deck looking from midships to starboard including fairleads, representative of the condition as seen onboard at the time of the inspection and, if so, was it free of any areas for concern?

Photograph Photo provided representative.

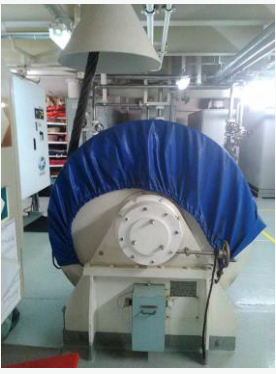
11.1.20. Was photograph no.20, aft emergency towing equipment storage arrangement, representative of the condition as seen onboard at the time of the inspection and, if so, was it free of any areas for concern?

Photograph Photo provided representative.

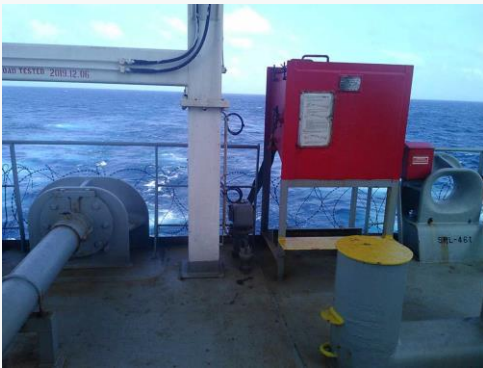
11.1.21. Was photograph no.21, aft emergency towing equipment deployment system, representative of the condition as seen onboard at the time of the inspection and, if so, was it free of any areas for concern?

Photograph Photo provided representative.

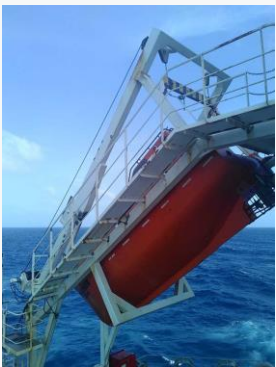
11.1.22. Was photograph no.22, lifeboat and davit, representative of the condition as seen onboard at the time of the inspection and, if so, was it free of any areas for concern?

Photograph Photo provided representative.

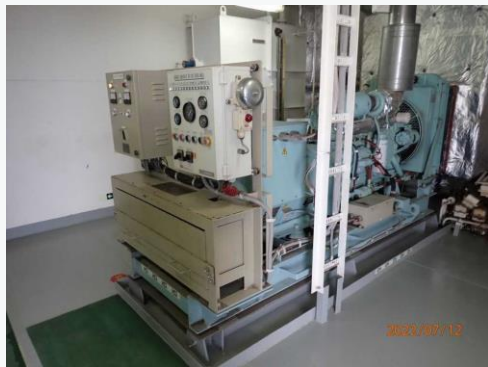
11.1.23. Was photograph no.23, the emergency generator or accumulator batteries, representative of the condition as seen onboard at the time of the inspection and, if so, was it free of any areas for concern?

Photograph Photo provided representative.

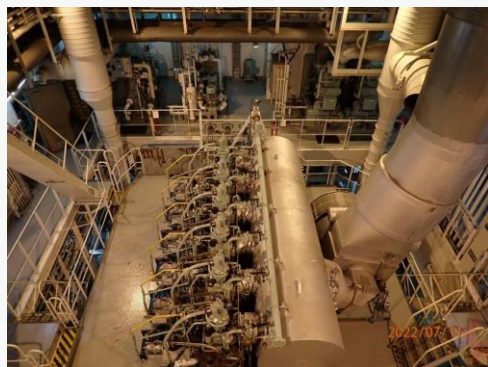
11.1.24. Was photograph no.24, engine room general view showing top of main engine, representative of the condition as seen onboard at the time of the inspection and, if so, was it free of any areas for concern?

Photograph Photo provided representative.

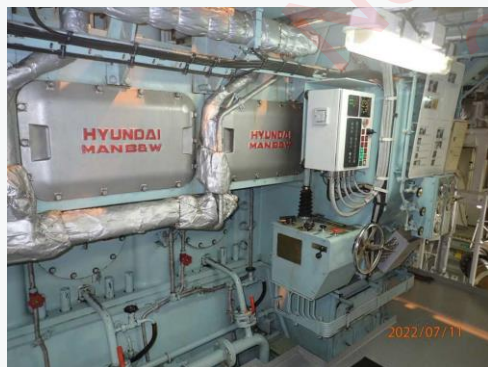
11.1.25. Was photograph no.25, one generator engine, representative of the condition as seen onboard at the time of the inspection and, if so, was it free of any areas for concern?

Photograph Photo provided representative.

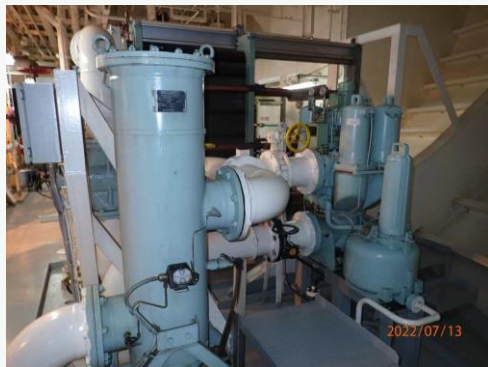
11.1.26. Was photograph no.26, the oil filtering equipment, representative of the condition as seen onboard at the time of the inspection and, if so, was it free of any areas for concern?

Photograph Photo provided representative.

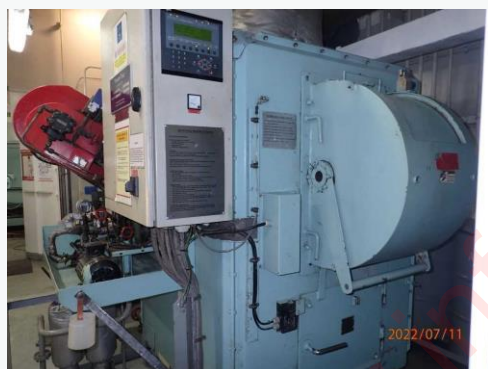
11.1.27. Was photograph no.27, the incinerator, representative of the condition as seen onboard at the time of the inspection and, if so, was it free of any areas for concern?

Photograph Photo provided representative.

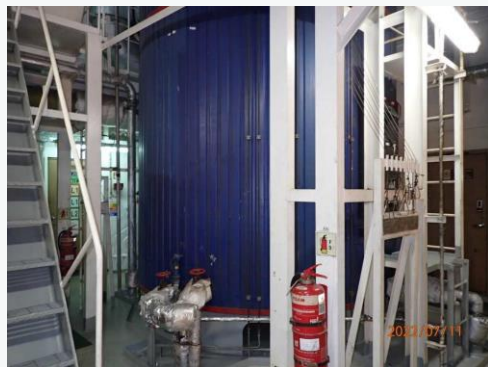
11.1.28. Was photograph no.28, one boiler from the front, representative of the condition as seen onboard at the time of the inspection and, if so, was it free of any areas for concern?

Photograph Photo provided representative.

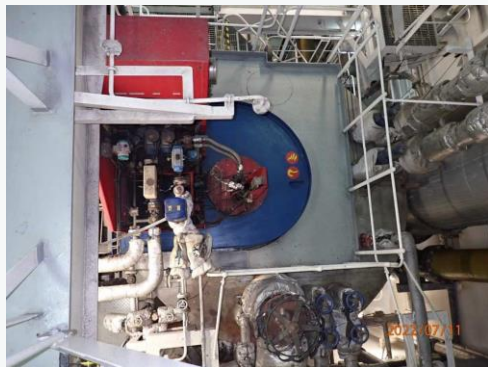
11.1.29. Was photograph no.29, one boiler from the top showing control equipment, representative of the condition as seen onboard at the time of the inspection and, if so, was it free of any areas for concern?

Photograph Photo provided representative.

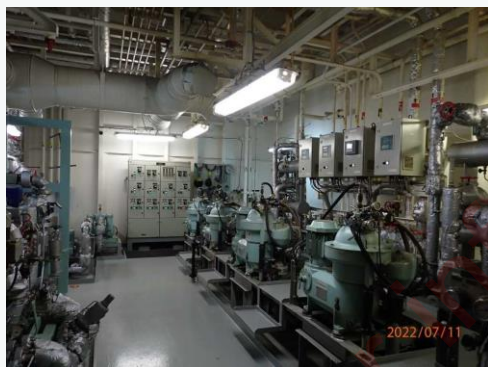
11.1.30. Was photograph no.30, purifier room general view, representative of the condition as seen onboard at the time of the inspection and, if so, was it free of any areas for concern?

Photograph Photo provided representative.

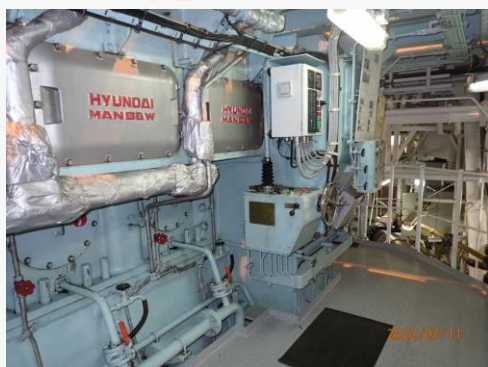
11.1.31. Was photograph no.31, main engine side showing local control station, representative of the condition as seen onboard at the time of the inspection and, if so, was it free of any areas for concern?

Photograph Photo provided representative.

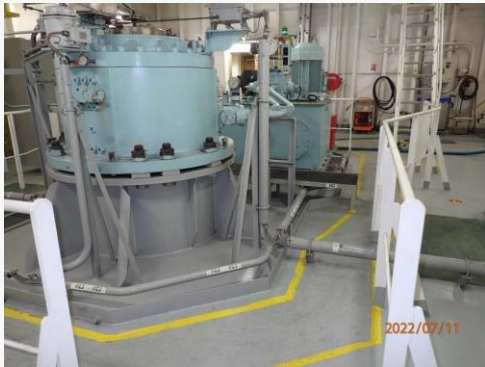
11.1.32. Was photograph no.32, steering gear room general view showing access, representative of the condition as seen onboard at the time of the inspection and, if so, was it free of any areas for concern?

Photograph Photo provided representative.

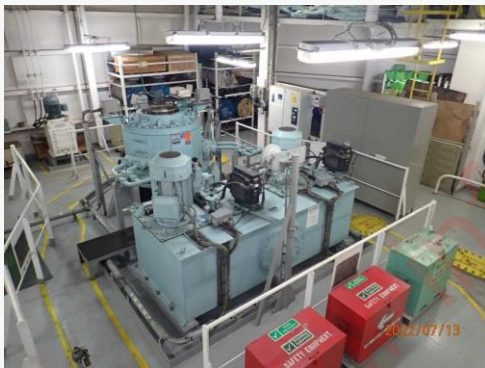
11.1.33. Was photograph no.33, main steering gear, representative of the condition as seen onboard at the time of the inspection and, if so, was it free of any areas for concern?

Photograph Photo provided representative.
