**OCIMF
Europe & Africa
Regional Marine
Forum
19 June 2018**

**MAIB investigation:
Failure of an HMPE
mooring line on board
LNG carrier *Zarga***

Howard Flegg
Inspector of Marine Accidents

Failure of HMPE mooring line on board LNG carrier *Zarga* resulting in serious injury to one crewman

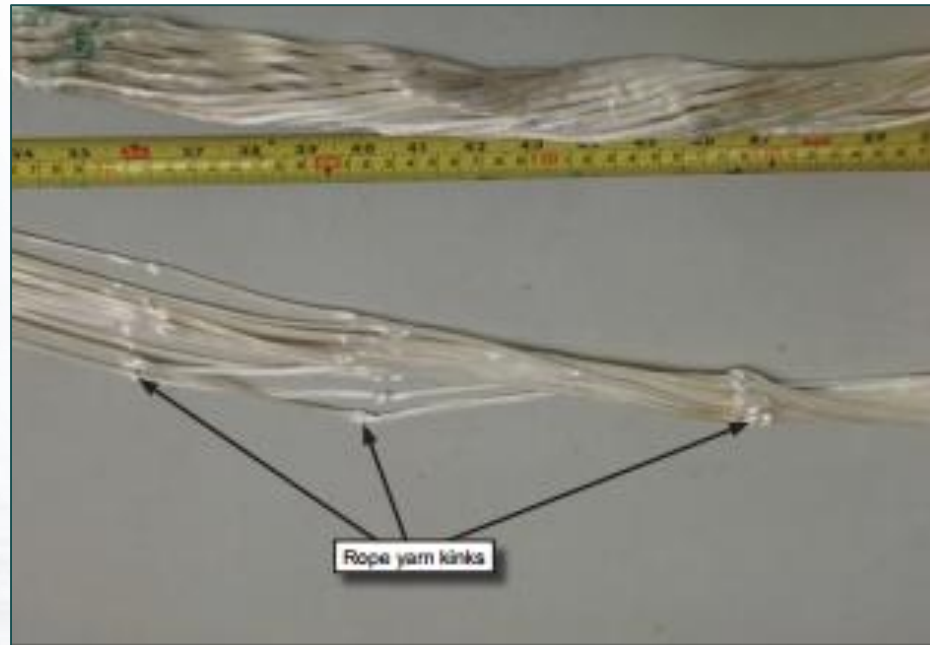
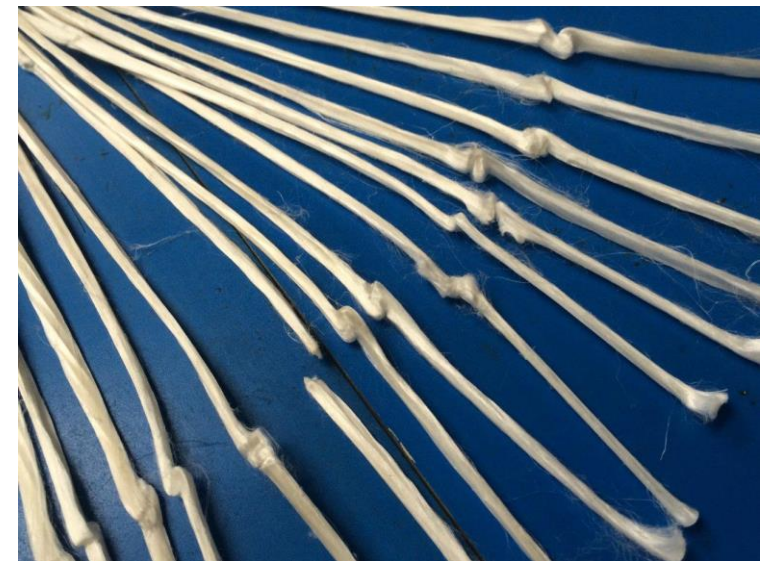
Failed rope inspection

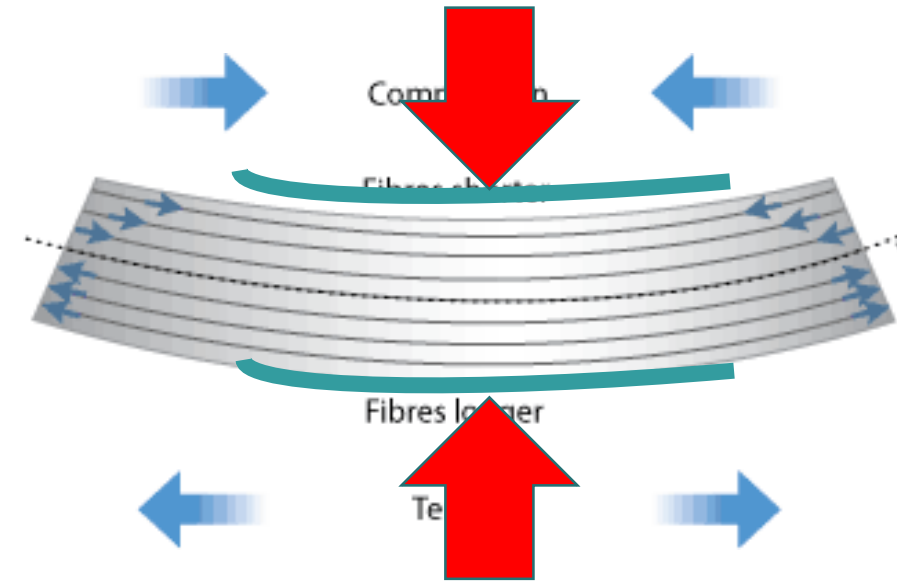
Zarga rope analysis report

- Yarns restrained under tension
- Bending under tension
- Radial compression of tight jackets
- Calculated full rope break strength (0.998)

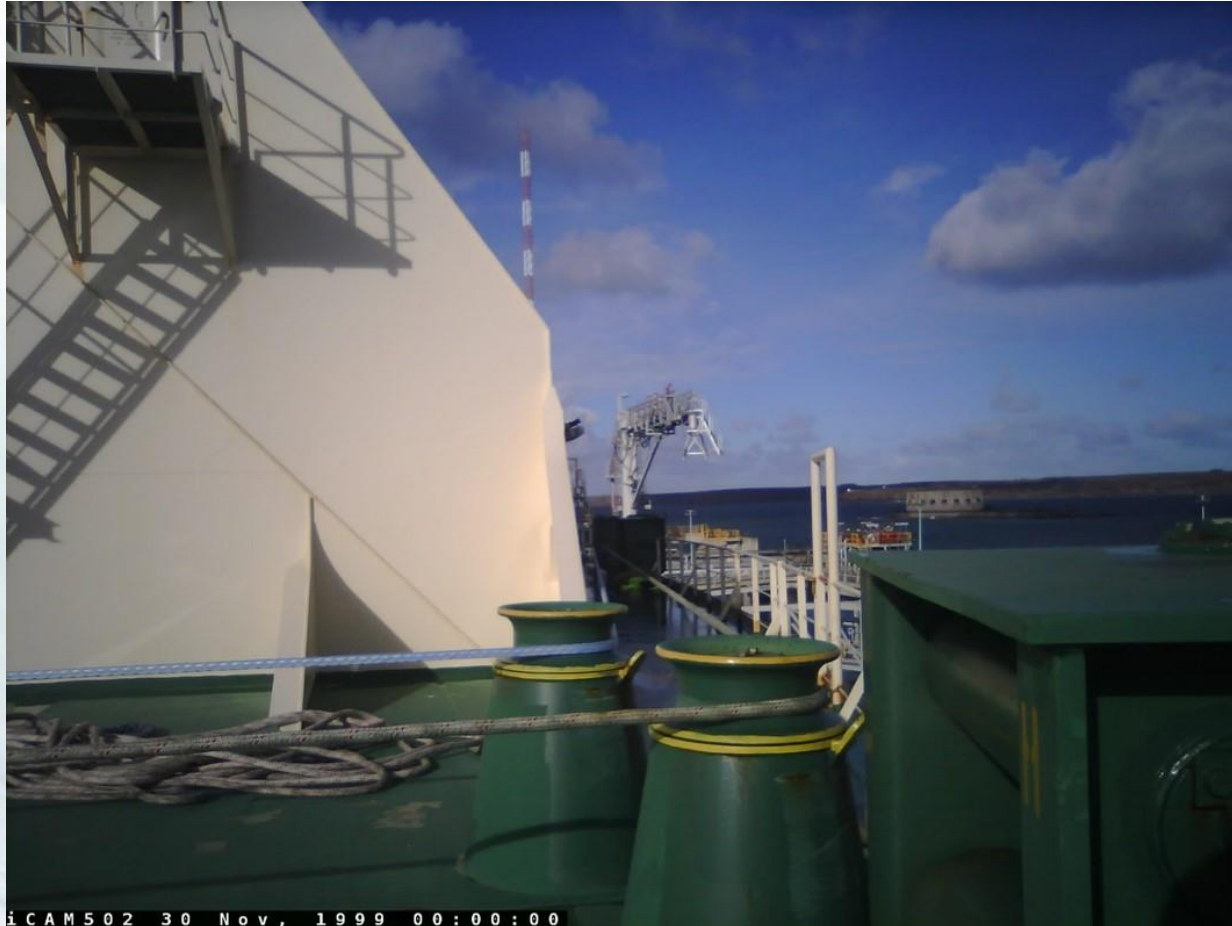
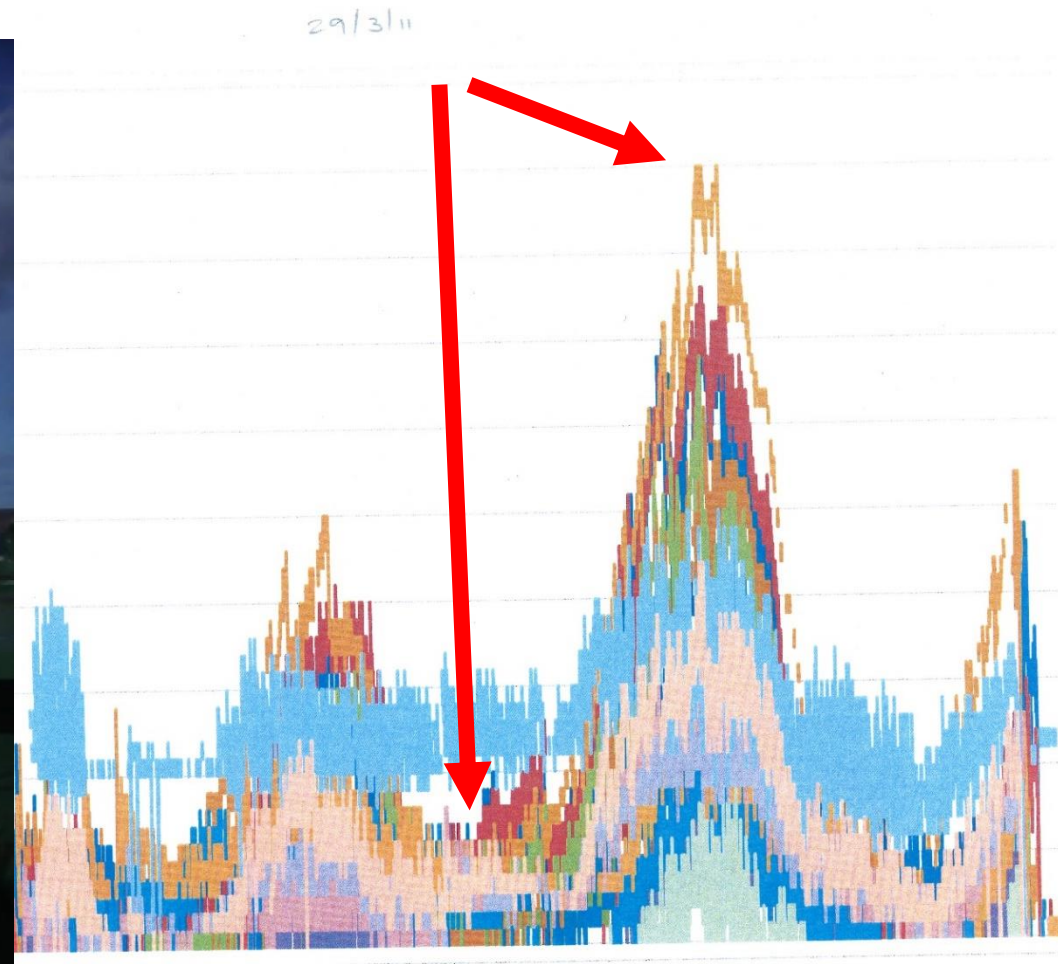
D/d ratios and cyclic mooring line loads

New rope dissection and modelling conclusions

- Small D/d ratios
- Compressive strain
- Rope jacket
- High cyclic loads

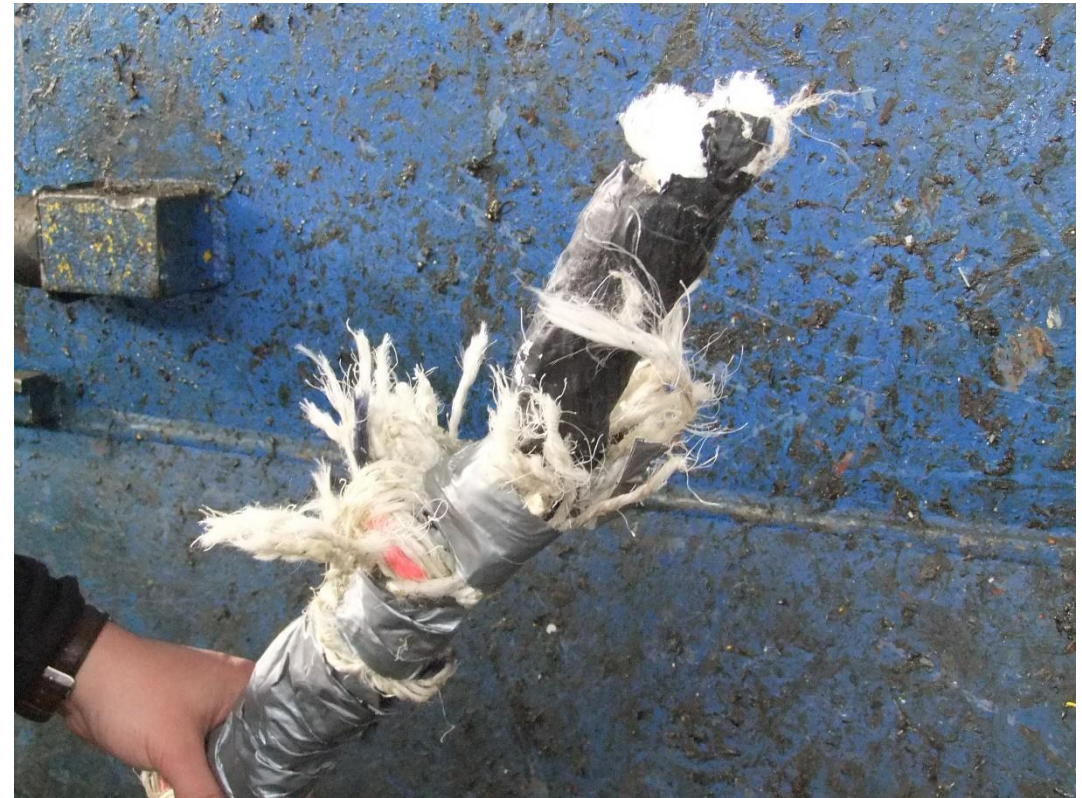
New Rope Full Load Break Tests VS Realisation Factors

- Specified MBL: 137T
- Realisation factor 0.998

New rope full load break tests

- Sample 1 break test: 101.46T
- Sample 2 break test: 105.64T
