# OCIMF Regional Marine Forum

Contractor Injured during Buoy Deployment

Date: March 15<sup>th</sup>, 2018

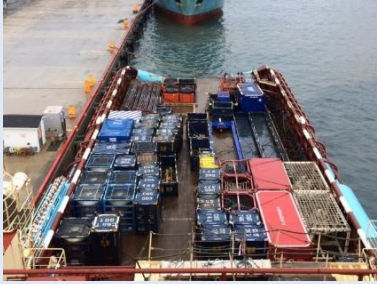
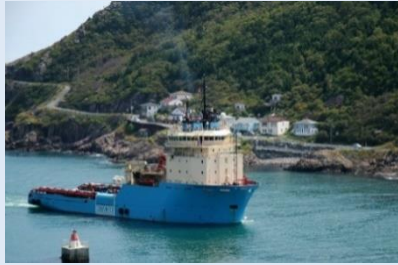
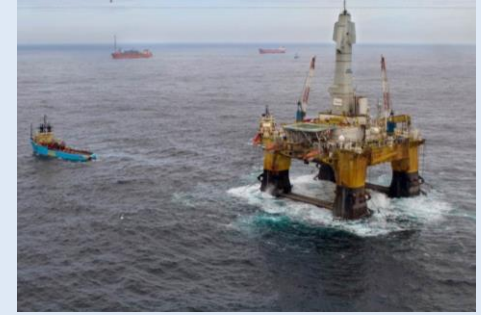
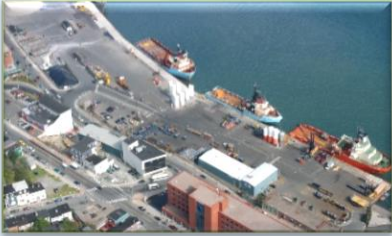
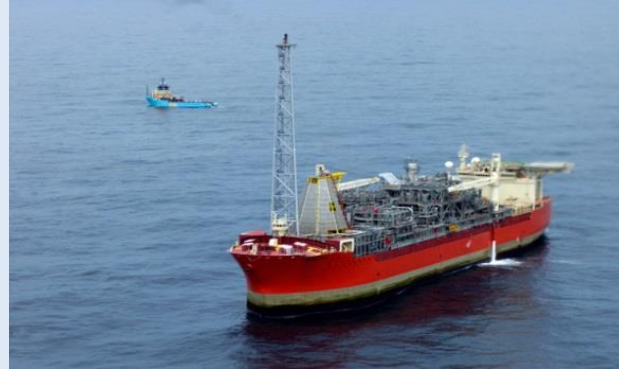
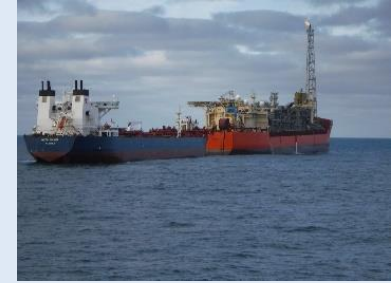
Rope removed from Starboard Propeller

Shackle that struck IP

12000lb Anchor

The Telemetry Buoy was deployed over the ships side from the main deck.

Vessel was operating in DP mode with heading into the wind. Moving fwd. both props engaged
